HANDBOOK FOR SUCCESSFUL PLANNING, INSTALLATION,
AND MONITORING OF WILDLIFE WATERERS

Technical Bulletin 86-1
January 1986

**BUREAU OF LAND MANAGEMENT
IDAHO STATE OFFICE
3380 Americana Terrace
Boise, Idaho 83706**

Handbook for Successful Planning,
Installation and Monitoring of Wildlife Waterers

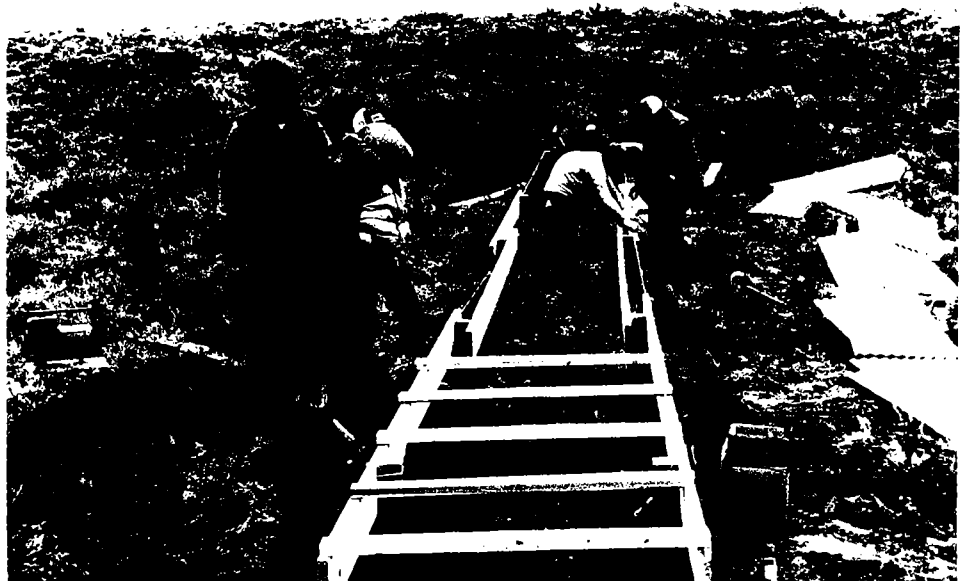
The 2"x4"s are sawed to 4' lengths and nailed to the top of the 2"x6"s. This provides the frame work for the tin. The boards should be spaced close enough to hold the tin securely (minimum of 30" spacing is recommended).

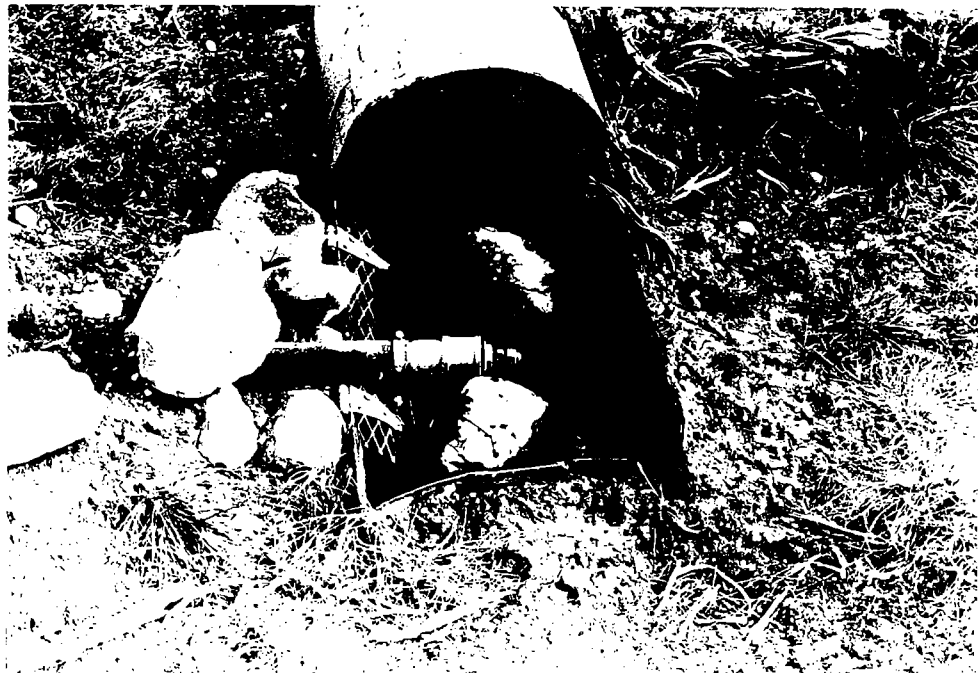
A small tank watered from a livestock pipeline. The trickler device allows a constant flow through the summer (unless it clogs with sediment). Larger storage tanks are necessary if water is not available through the dry period of the year.

The pictures following Figure 2 show volunteers and Idaho Department of Fish and Game personnel installing a tank and catchment. Also shown is a small tank with a trickler hose from a livestock pipeline. The small tank is adequate where pipelines are operated throughout the summer and a constant trickle of water is provided.
